# Local site effects and incremental damage of buildings during the 2016 Central Italy earthquake sequence

Anastasios Sextos,<sup>a)</sup> M.EERI Raffaele De Risi,<sup>a)</sup> Alessandro Pagliaroli,<sup>b)</sup> Sebastiano Foti,<sup>c)</sup> Federico Passeri,<sup>c)</sup> M.EERI Ernesto Ausilio,<sup>d)</sup> Roberto Cairo,<sup>d)</sup> Maria Chiara Capatti,<sup>e)</sup> Filiberto Chiabrandi,<sup>f)</sup> Anna Chiaradonna,<sup>g)</sup> Shideh Dashti,<sup>h)</sup> Filomena De Silva,<sup>g)</sup> Francesca Dezi,<sup>i)</sup> Maria Giovanna Durante,<sup>j)</sup> Silvia Giallini,<sup>b)</sup> Giuseppe Lanzo,<sup>k)</sup> Stefania Sica,<sup>l)</sup> Armando L. Simonelli,<sup>l)</sup> Paolo Zimmaro,<sup>j)</sup> M.EERI

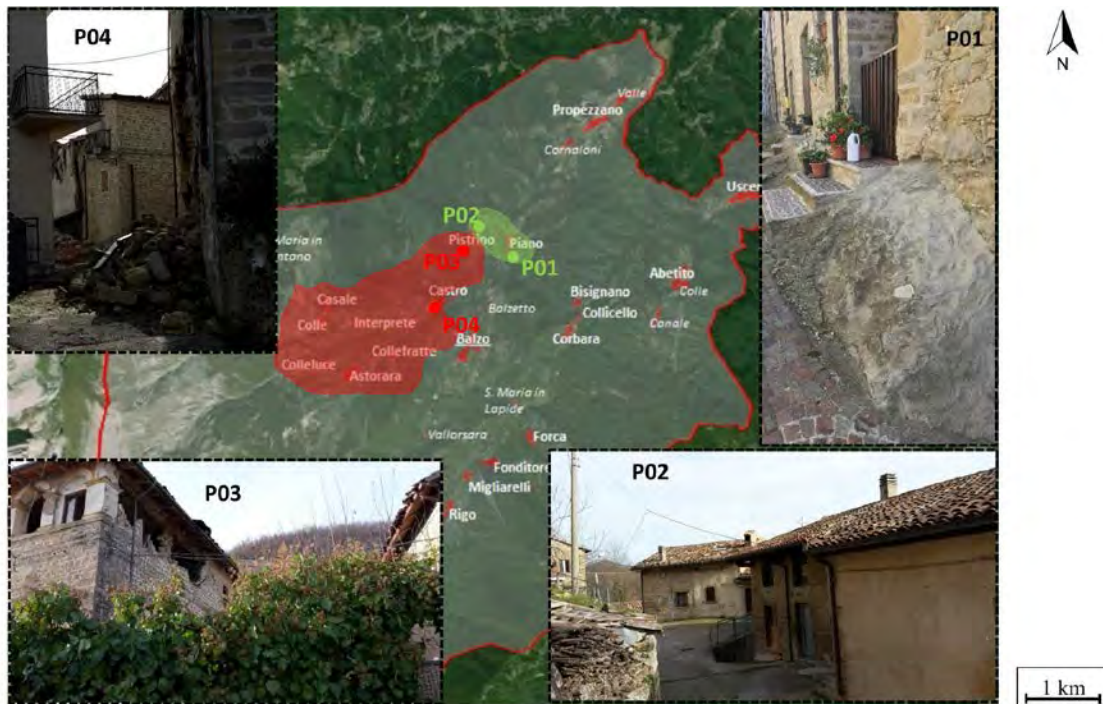
**Figure 3.** Spatial distribution of building damage across the municipality of Montegallo.

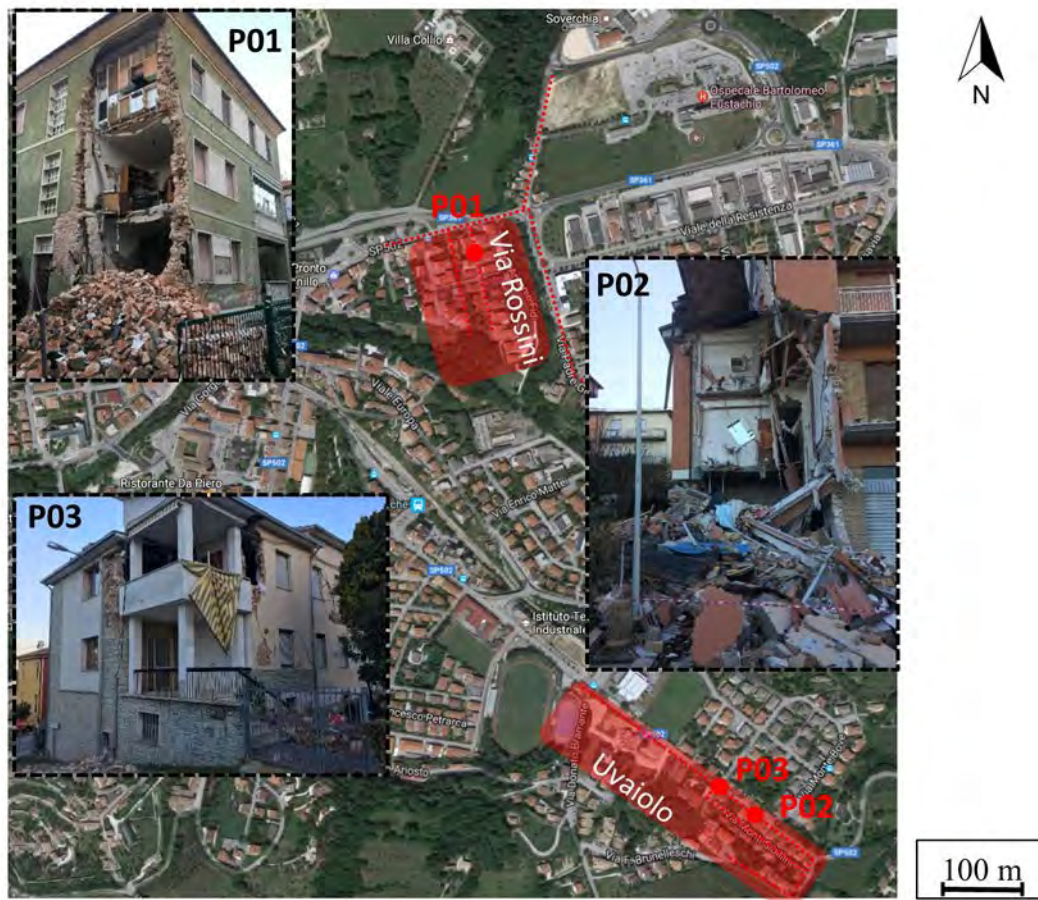
Other examples of local site effects were identified in some areas of San Severino Marche (number 11 in Figure 2). San Severino Marche is a town in the Province of Macerata, in the Marche region, located about 50 kilometers south-west of Ancona and about 25 kilometers south-west of Macerata. It has about 12,000 inhabitants, and it comprises more than 40 hamlets. Unlike Montegallo, San Severino has districts where most of the buildings are of reinforced concrete, built in the 1960s and the 1970s. Within San Severino Marche, two neighborhoods along Via Mazzini and Via Rossini attracted most of the GEER reconnaissance team attention due to the evident and quite localized damage observed (Figure 4). Via Mazzini is located uphill while buildings along Via Rossini are constructed on the ancient riverbed of the Potenza River. It is deemed that stratigraphic amplification is likely to have taken place due to the presence of soft shallow sediments resulted from the river artificial channeling operations. Similar damage patterns and site effects have been observed in Tolentino (number 10 in Figure 2), as described in GEER (2017).

**Figure 4.** Characteristic building damage within the town of San Severino Marche.

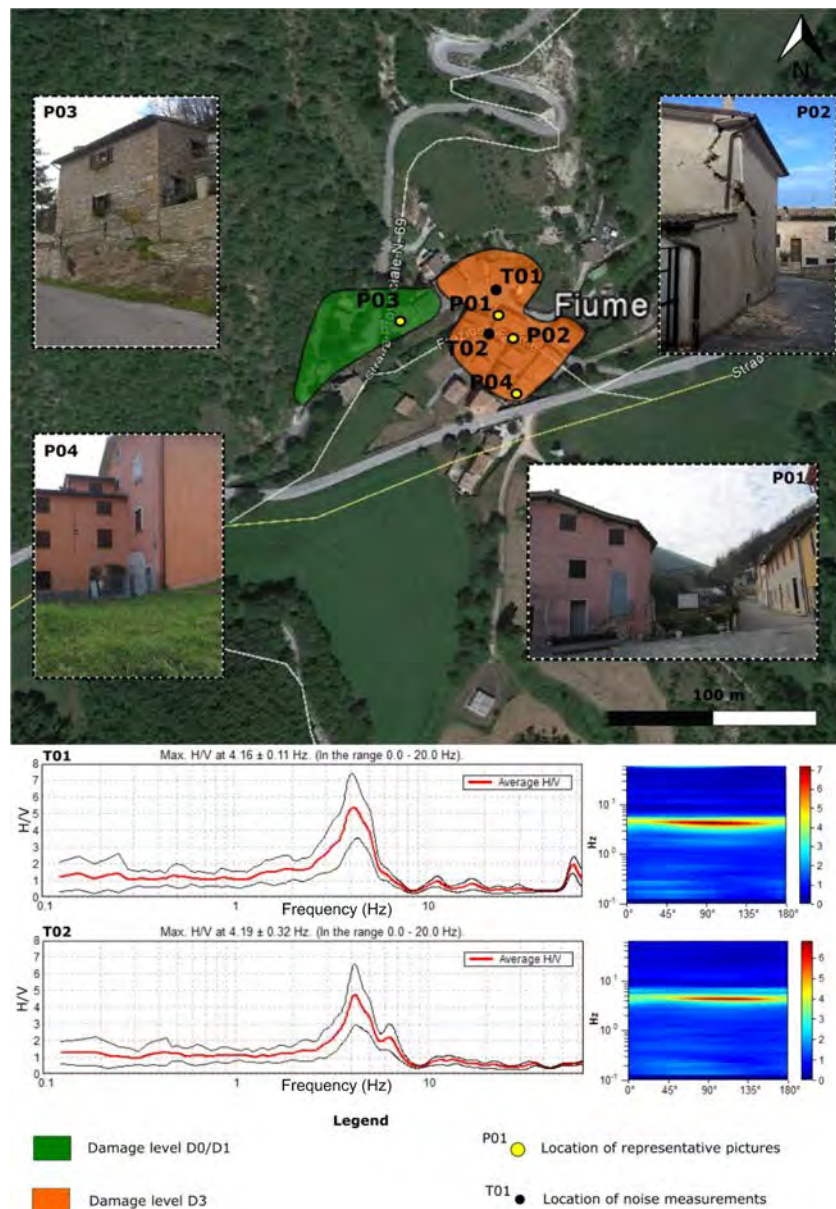
265 eastern part of the hamlet, founded on colluvial and alluvial deposits resting on bedrock,  
266 suffered high levels of damage (D3) as shown in reference pictures P01-P02-P04, whereas  
267 the western part, built on travertine rock, had only negligible damage (D0/D1, P03).

268 Two noise measurements (T01-T02 in Figure 5) were performed in the damaged zone  
269 (east side of the hamlet) during the GEER mission. A portable Tromino tomograph was  
270 employed and the total duration of each measurement was approximately 15 minutes.  
271 Horizontal-to-Vertical (H/V) spectral ratios were computed by using the geometrical mean of  
272 horizontal components. In addition, H/V ratios were computed by rotating the horizontal  
273 component between 0° and 180° (directional or polar HVSR), in order to investigate  
274 preferential directions of site amplification (i.e., the polarization of ground motion). Both  
275 H/V and polar H/V are reported in Figure 5 showing a large H/V peak around 4 Hz, which  
276 shows significant stiffness contrast between the upper soil layers and the underlying bedrock,  
277 i.e. a typical proxy of local site amplification.

**Figure 5.** Damage zonation within the village of Fiume (up). Location and results of noise measurements in terms of H/V spectral ratio (bottom left) and polar plot (bottom right).

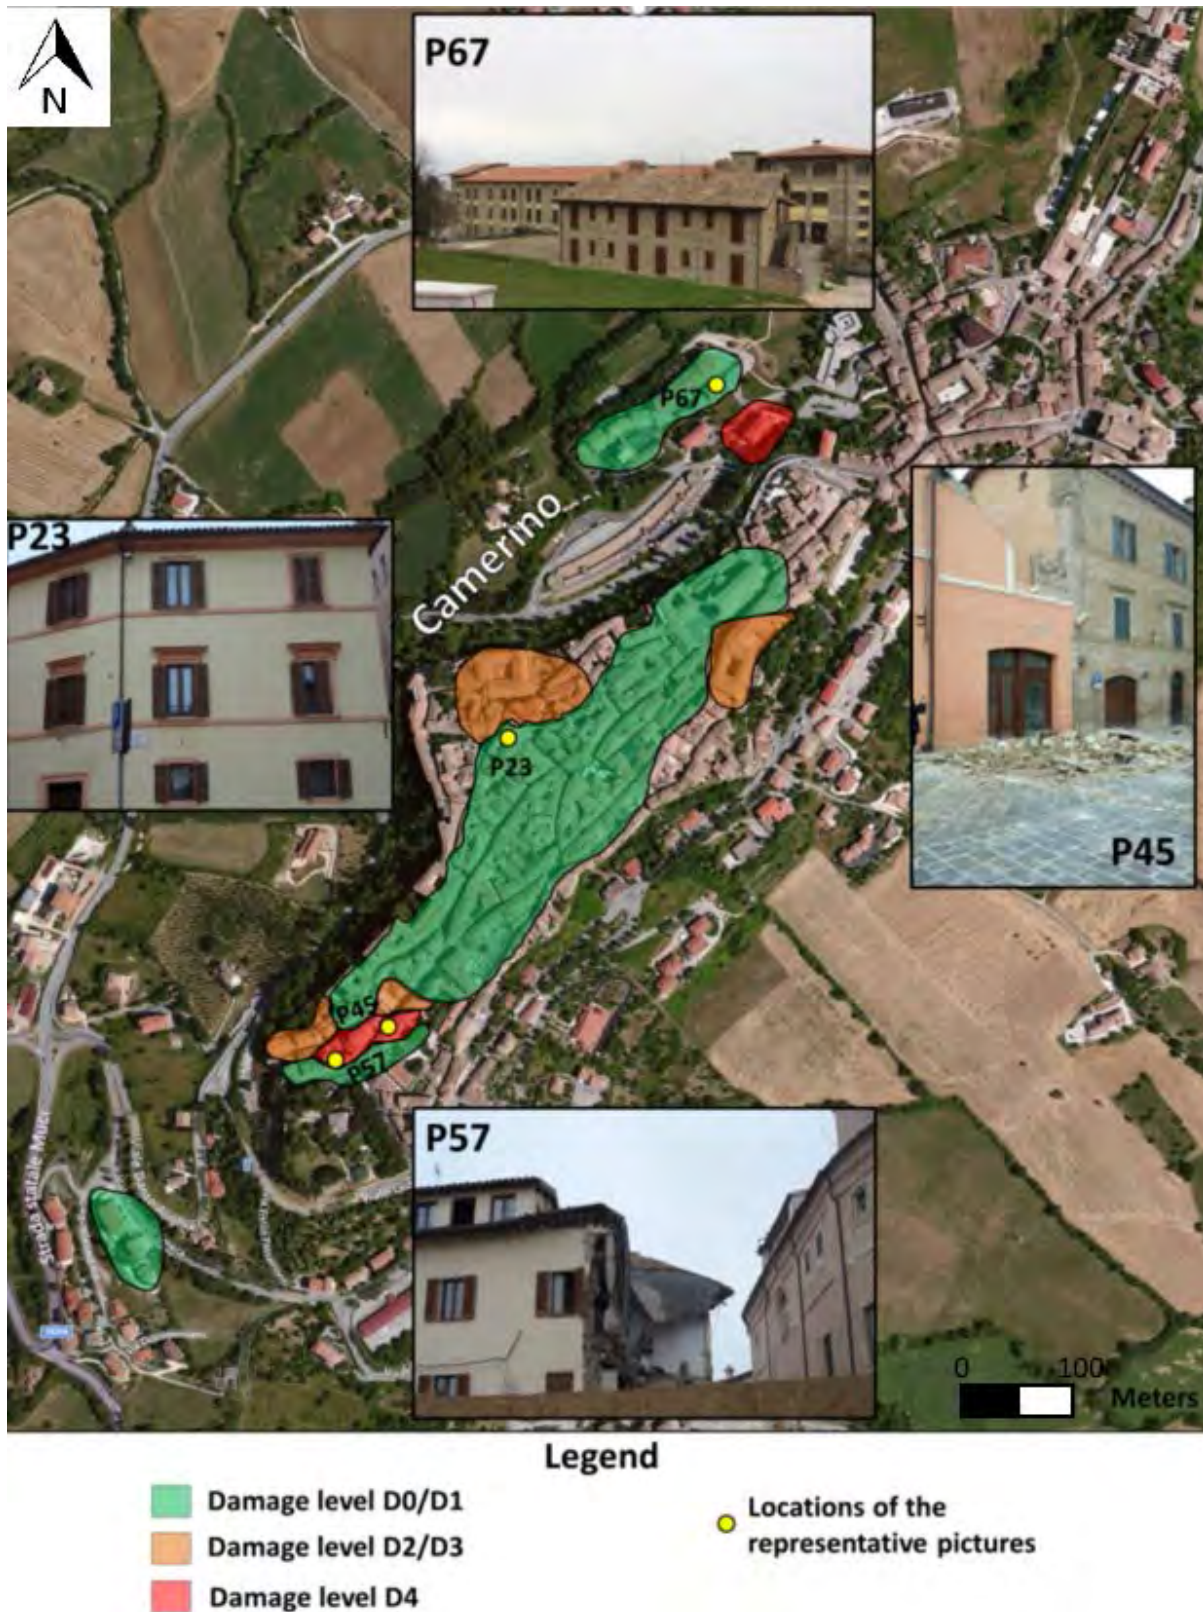
Figure 6 depicts the damage distribution across the main village, as inspected after the 30 October event. Relatively low damage (D0 or D1) were observed within the inner part of the ridge characterized by local bedrock (GRS) outcrops. Higher damage levels (D2-D3) were observed for many of the low rise (2-3 stories) unreinforced masonry buildings, even if some of them were partially retrofitted. The damage is mainly localized on the hillside, where potential topographic amplifications and permanent deformation (due to slope instability) may be occurred. The highest damage level (D4) was observed at the SW side of the historic center and at the bottom of the Camerino hill, where several masonry structures collapsed. The observed damage distribution pattern in Camerino is consistent with site effects that could be inferred from the geological map shown in Figure S5. Strong amplification of earthquake ground motions is highly probable given the thin soft layers of eluvio-colluvial soils (ML) overlying the bedrock.

**Figure 6.** Damage zonation within the historic center of Camerino with pictures of the representative structures inspected.

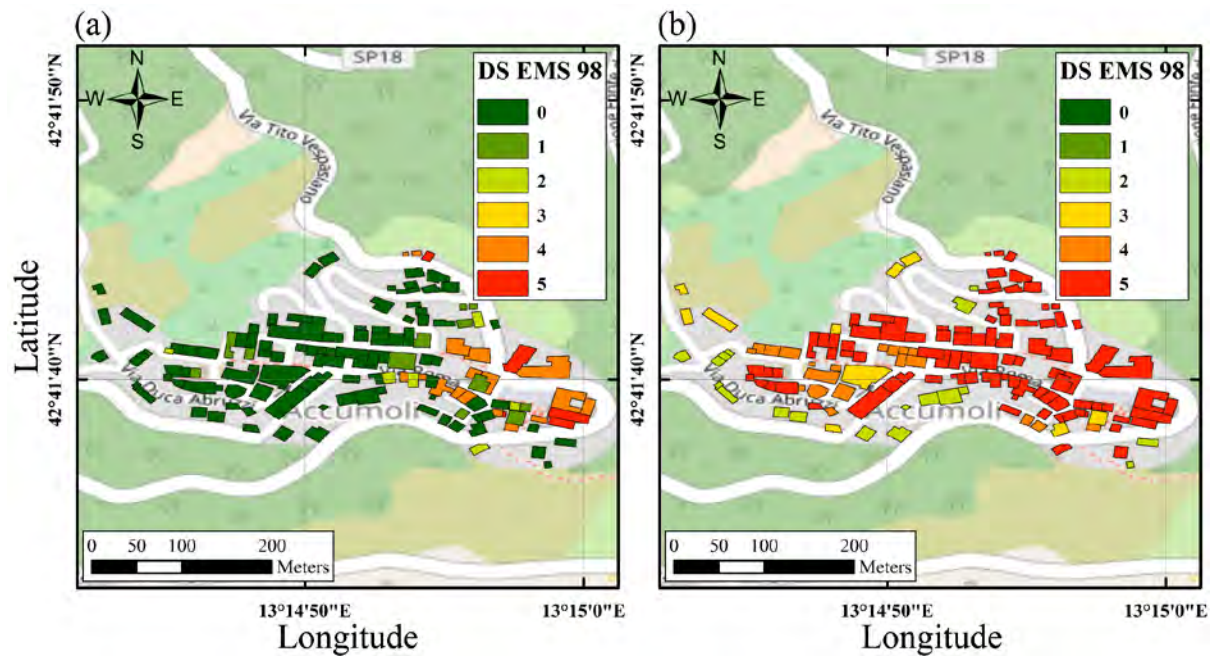
Figure 7 illustrates the structural damage levels observed during the two surveys, after the 24 August (left) and the October events (right). After the August 24th event, the most severe damage was observed at the eastern side of the village, while the vast majority of the building stock retained its structural integrity null or with minor damage (D0-D1). However, at the end of the seismic sequence, Accumoli was almost completely destroyed. Few buildings, in the south end of the village survived the sequence of events with limited damage (D2).

**Figure 7.** Damage levels in the main village of Accumoli (a) after the first earthquake and (b) at the end of the entire sequence.

The evolution of structural damage during the earthquake sequence is clearly reflected in the observed damage: 72% of the buildings experienced zero (DS0) and 8% minor damage (DS1) after the first earthquake, while not a single building was found intact or with minor damage after the seismic sequence. Large damage states were in contrast more populated (4% to 13% for DS2, 0% to 7% for DS3, 12% to 14% for DS4, and a major shift from 4% to 65% for DS5).

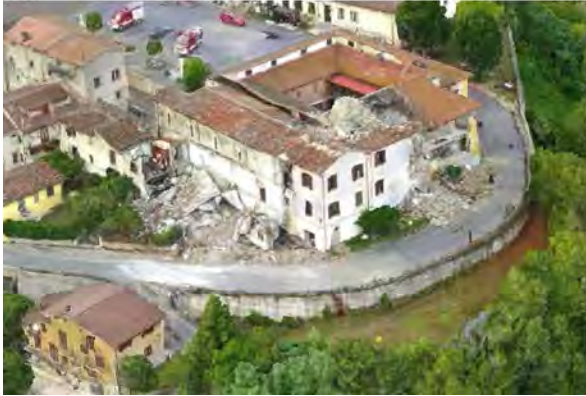
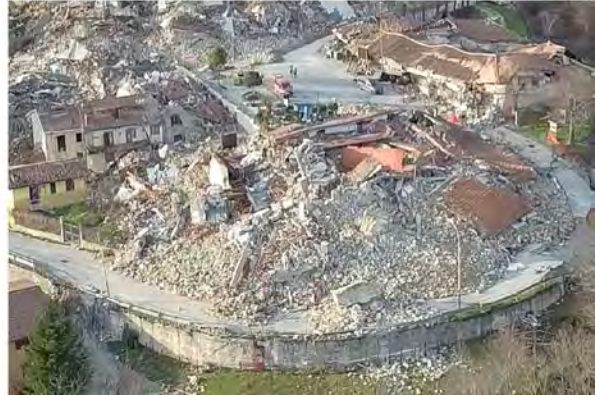
Figures 8a and 8b show an aerial view of the east part of the village during the first and the second surveys, respectively, including the local church and the police station, which eventually collapsed because of multiple earthquake excitations. Figures 9, 10 and 11 illustrate characteristic cases of minor-to-moderate shear and out-of-plane damage after the August event that led to abrupt collapse because of the earthquake sequence. Age of construction, high spectral accelerations for periods lower than 0.3s (which match the natural periods of low-rise buildings) and the variation of spectral polarization across several events were likely the main contributors to the observed catastrophic damage patterns. Given the location of Accumoli, topographic effects may also have contributed to the observed damage.

**Figure 8.** Aerial photos of the east side of Accumoli after (a) the first earthquake and (b) the entire earthquake sequence.

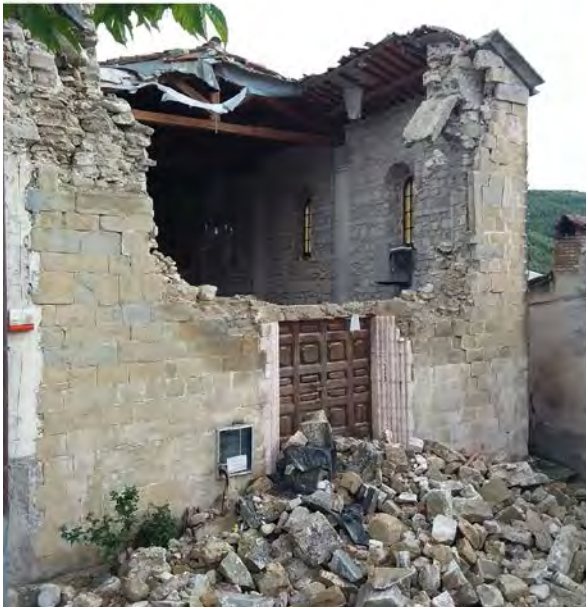
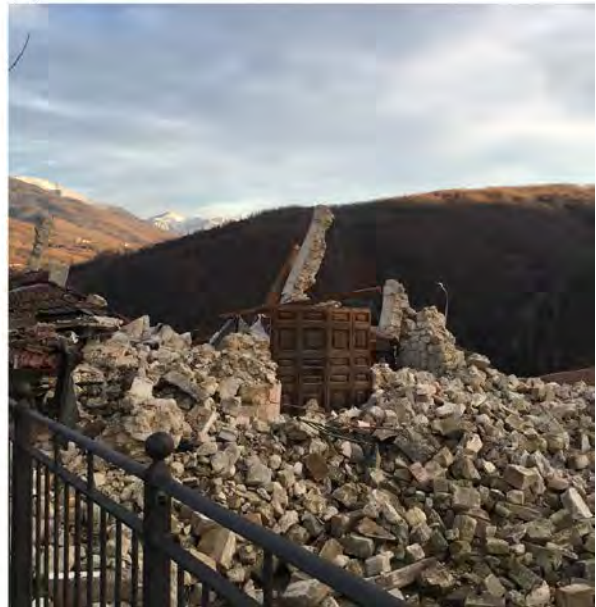
**Figure 9.** The local church: (a) after the first earthquake; and (b) after the entire sequence.

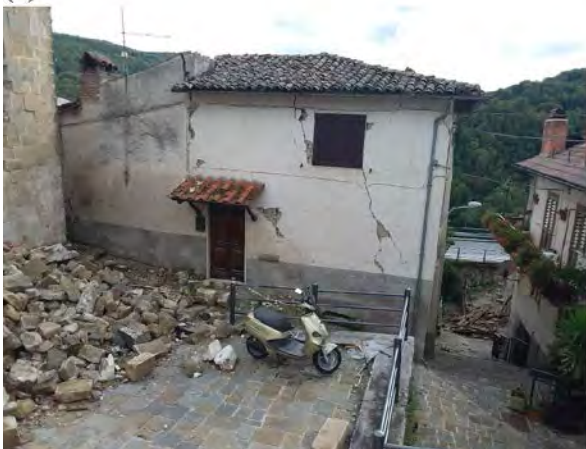
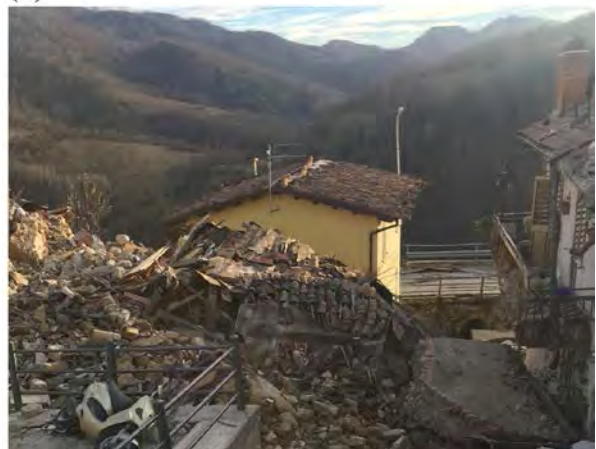
**Figure 10.** Masonry residential building: (a) after the first earthquake; and (b) after the sequence.

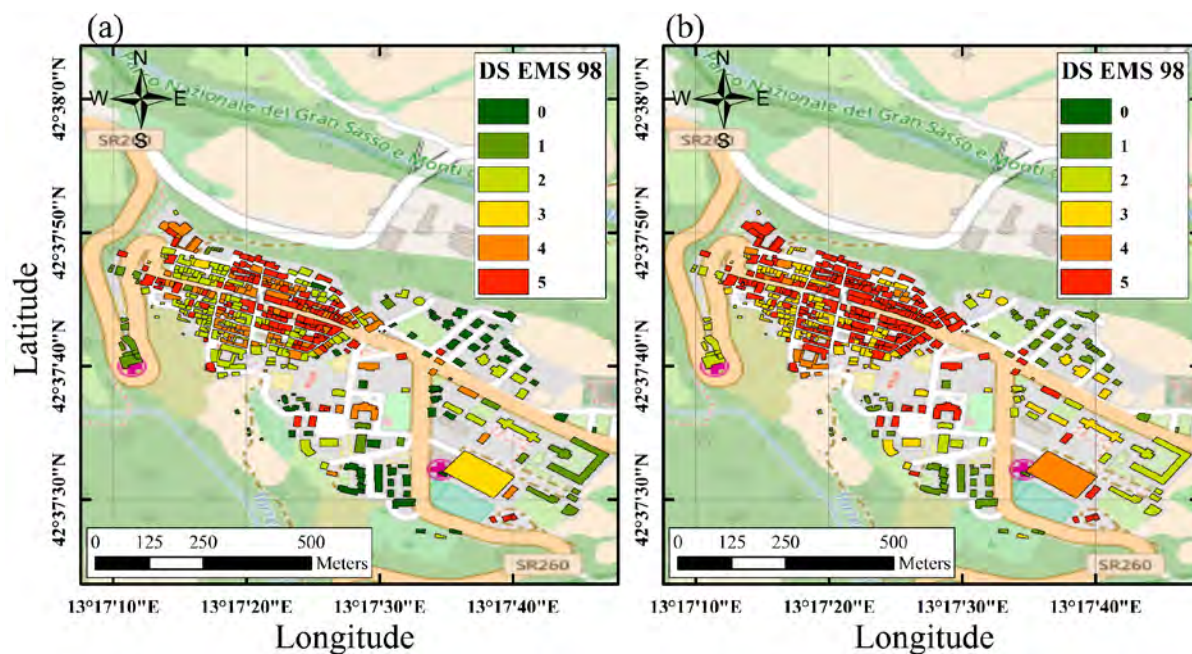
Figure 12 shows the structural damage levels observed during the two surveys. The 24 August event caused severe damage to the south-east part of the historical city center along the main avenue (Corso Umberto I). As observed in the case of Accumoli, many buildings that were still standing after the first event with only a small residual capacity to additional horizontal actions, fully collapsed because of the subsequent September and October events. The shifting of damage states between the aftermath of the first event and the end of the

entire sequence is reflected in the following inspection results clearly indicating a major shift to most critical damage states: intact buildings (D0) were reduced from 30% to 18%, buildings with minor damage (D1) were increased from 5% to 10%, moderate damage (D2) was reduced from 24% to 6%, D3 increased from 1% to 21%, D4 decreased from 17% to 3%, and collapsed buildings (D5) had a significant increase from 23% to 42%.

**Figure 12.** Damage levels observed in the center of Amatrice (a) after the 24 August earthquake (during the first survey), and (b) after the entire sequence (during the second survey).

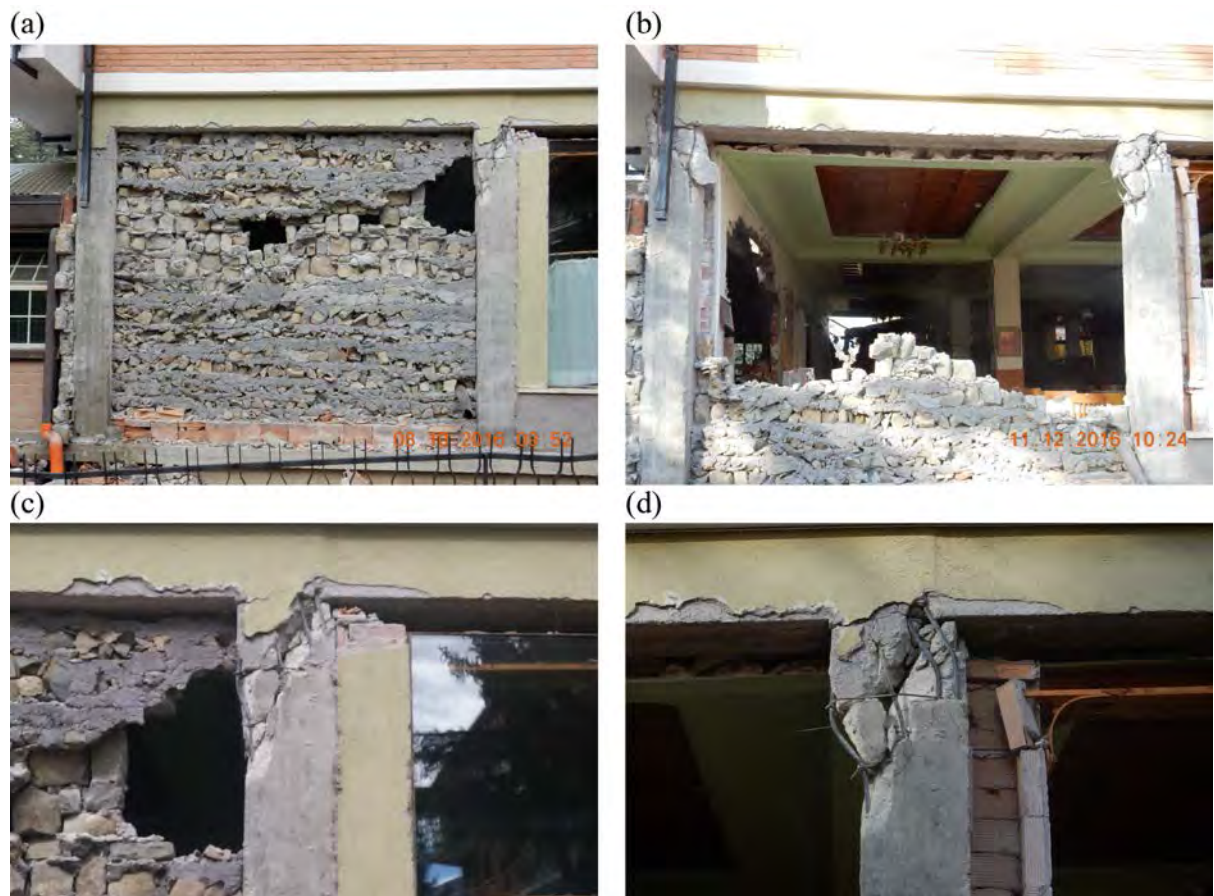
**Figure 13.** Reinforced concrete residential building (a,c) after the 24 August earthquake and (b,d) after the entire sequence. (a,b) External infill failure and (c,d) shear failure at the column top.

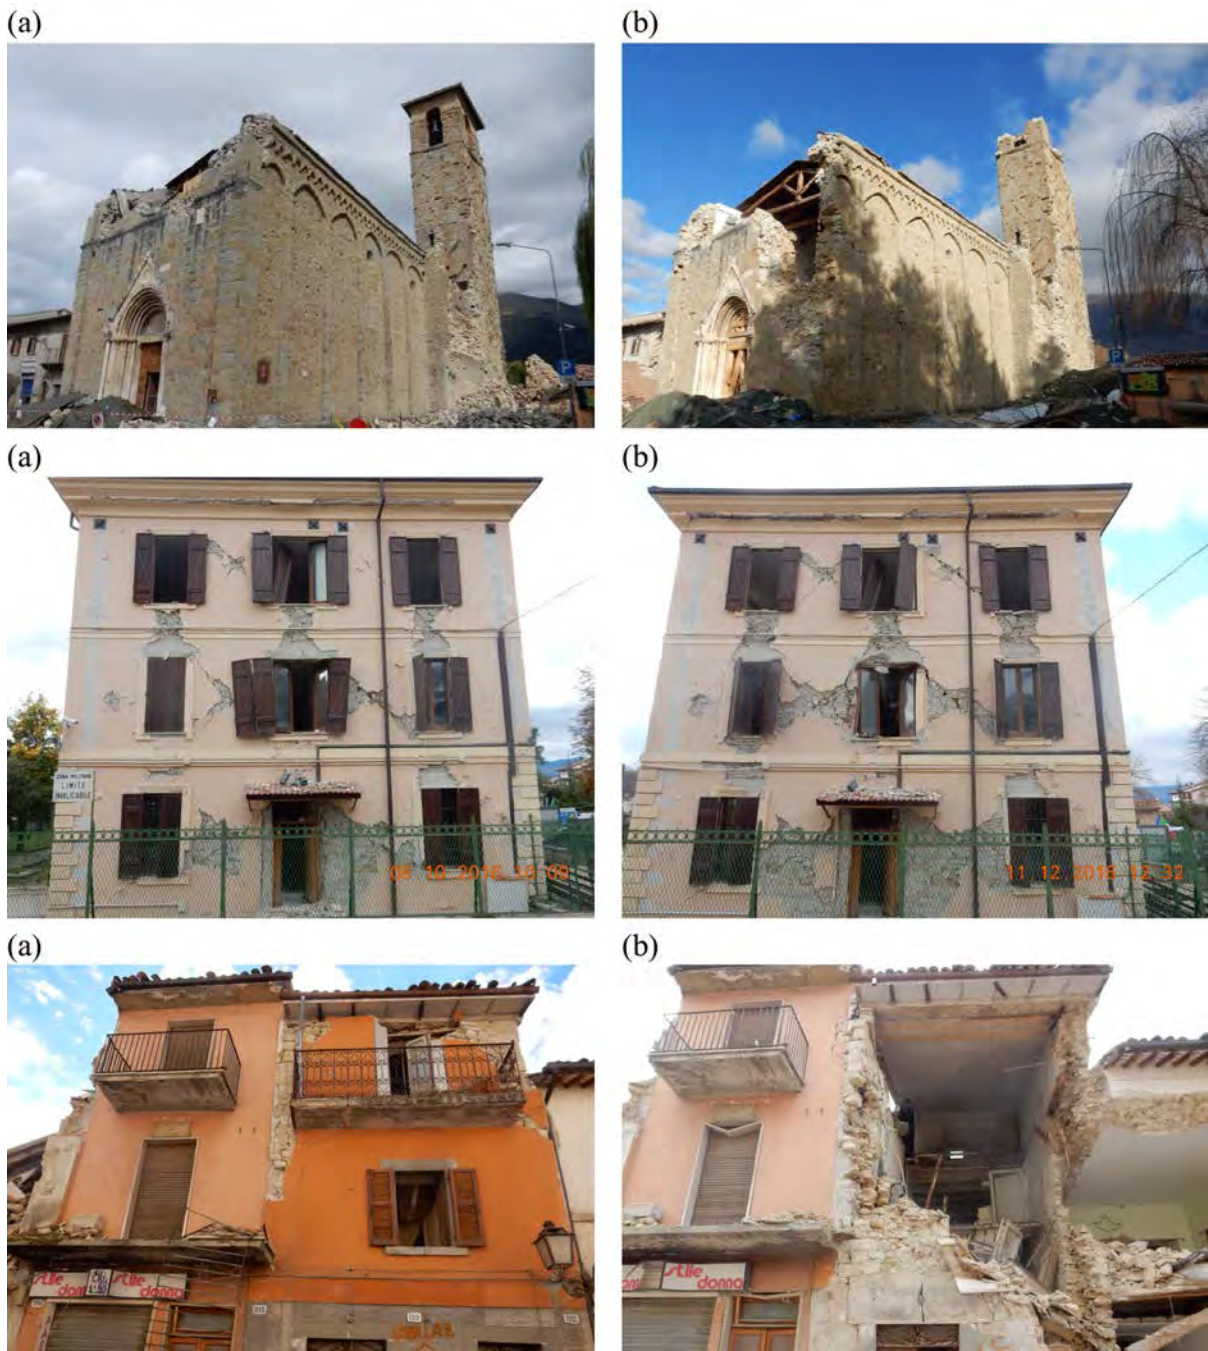
also clearly seen in several characteristic masonry structures, such as the church of Sant’Agostino (Figure 17, top), the local police (“Carabinieri”) station (Fig. 17, middle) and typical residential buildings (Fig. 17 bottom and Fig. 18).

**Figure 17.** Incremental structural damage of the church of Sant’Agostino (top), the local police station (middle) and one of the several masonry buildings collapsed after (a) the event of 24 August earthquake and (b) the entire sequence.

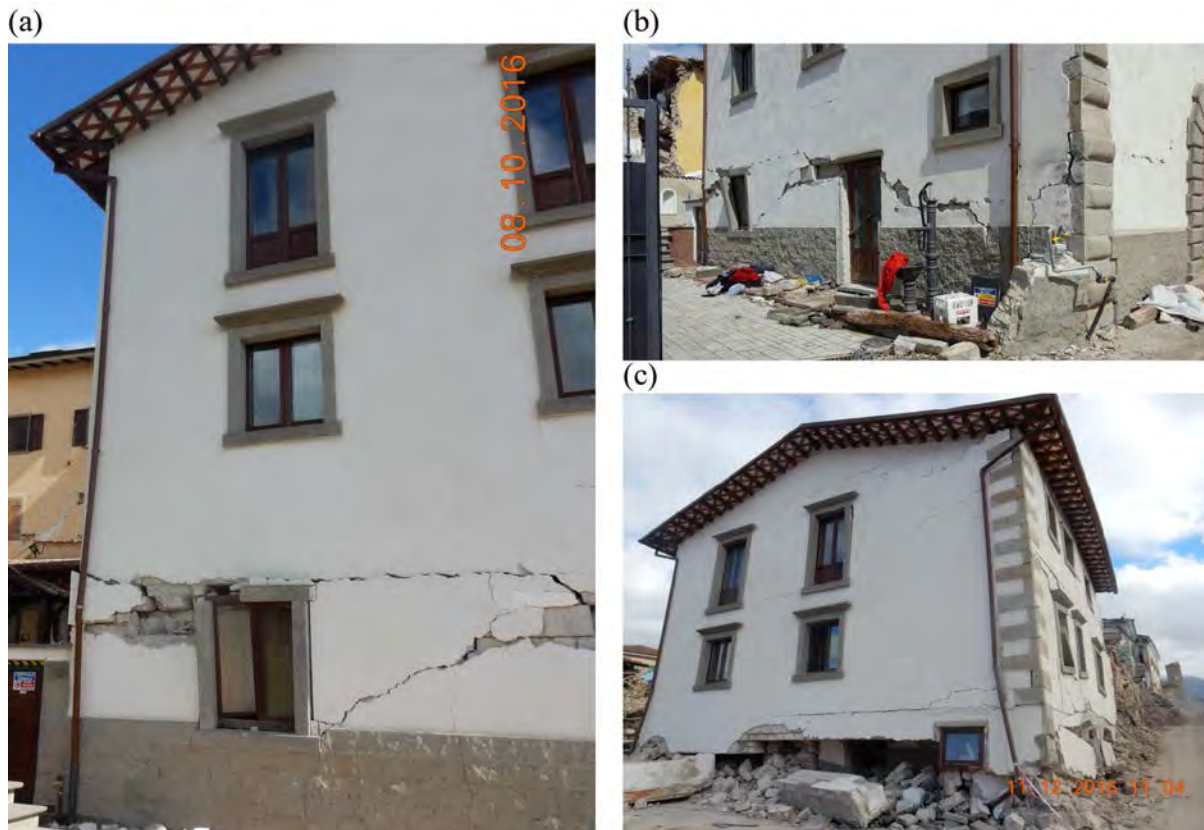
**Figure 18.** Residential masonry residential building after the 24 August earthquake (a, b) and (c) after the entire sequence. Shear failure of the ground floor bearing wall leads to soft story collapse at the end of the third event.

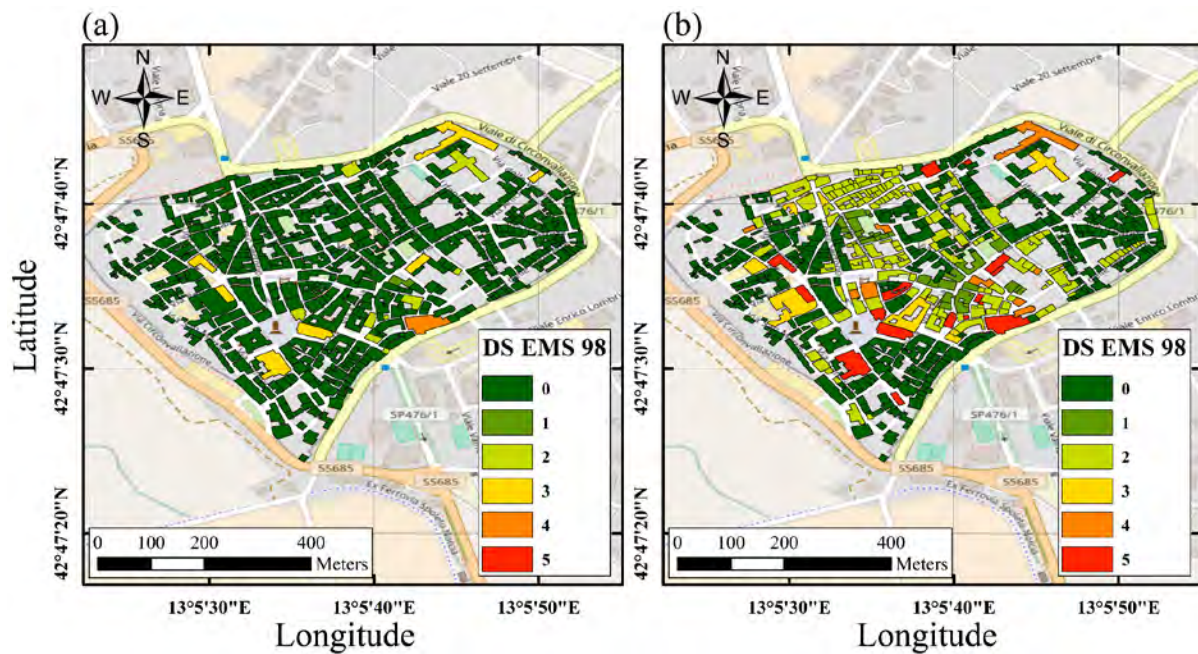
514 Figure 19 shows the structural damage levels observed during the two inspection  
515 campaigns. Following the 24 August earthquake, only a small number of buildings  
516 experienced medium or severe damage, located mainly in the historical center of the town.  
517 This good performance can be primarily attributed to two reasons. First, after the 1859  
518 earthquake, the reconstruction of Norcia was based on a set of new practical rules of thumb  
519 prescribing a minimum wall thickness, the use of buttresses, the reduction of building height,  
520 the use of vaults only at ground floor and the mandatory presence of good wall-to-wall  
521 connections. The increased wall thickness is still visible in many structures, and in several  
522 buildings, the wall thickness varies linearly along the height of the first story. Secondly, a  
523 series of repair and strengthening works followed the 1997 Umbria-Marche event, which

observed at the end of the seismic sequence, mainly in heritage construction such as churches and monasteries. The following variation of cumulative damage was reflected in the statistical distribution of the different damage states: intact buildings (DS0) were reduced from 97% after the first earthquake to 67%, which was a substantial change in structural behavior. Minor damage (DS1) also increased at the end of the entire sequence to 4% from almost 0% after the first event. The same applies to moderate damage (DS2), it increased from 1% to 24%, previously, and to DS5 increased from 0% to 3% in the first event, DS3 and DS4 remaining practically constant.

**Figure 19.** Damage distribution in the historical center of Norcia (a) after the 24 August event and (b) at the end of the entire seismic sequence.

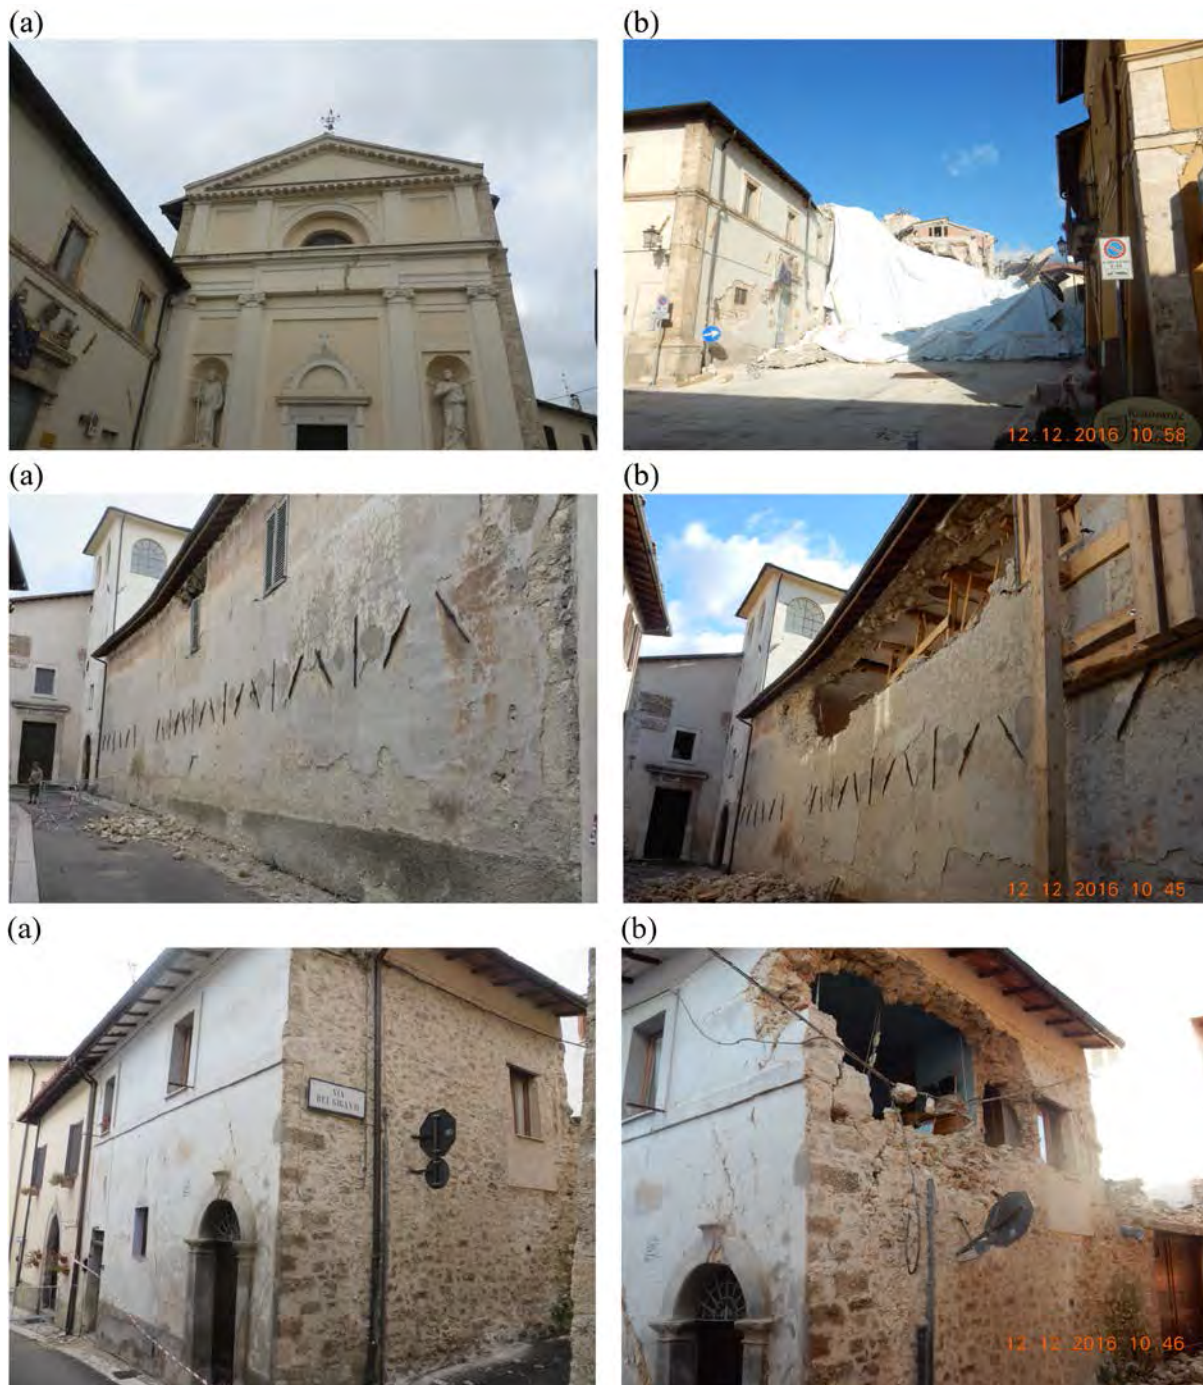
Figure 20 (top) shows one of the churches that was slightly damaged by the **M**6.1 24 August seismic event but collapsed following the **M**6.5 30 October event. Many historical churches in Norcia experienced similar damage evolution, as shown for instance in Figure 20 (middle), where the out-of-plane failure of a historic monastery and the partial loss of support of the roof is depicted. Notably, the wall failure was concentrated at a level higher to that of the seismic retrofit, thus highlighting that the retrofit shall not be only localized on the ground level but also take into consideration the reduced axial load and weak diaphragm action of the masonry walls at the higher level. Figure 20 (bottom) shows two masonry residential buildings with irregular masonry construction that experienced only minor cracking during the first earthquake, but significant out-of-plane and in-plane wall failure under subsequent events.

**Figure 20.** Seismic damage observed in characteristic masonry buildings (a) after the 24 August earthquake and (b) at the end of the entire seismic sequence.

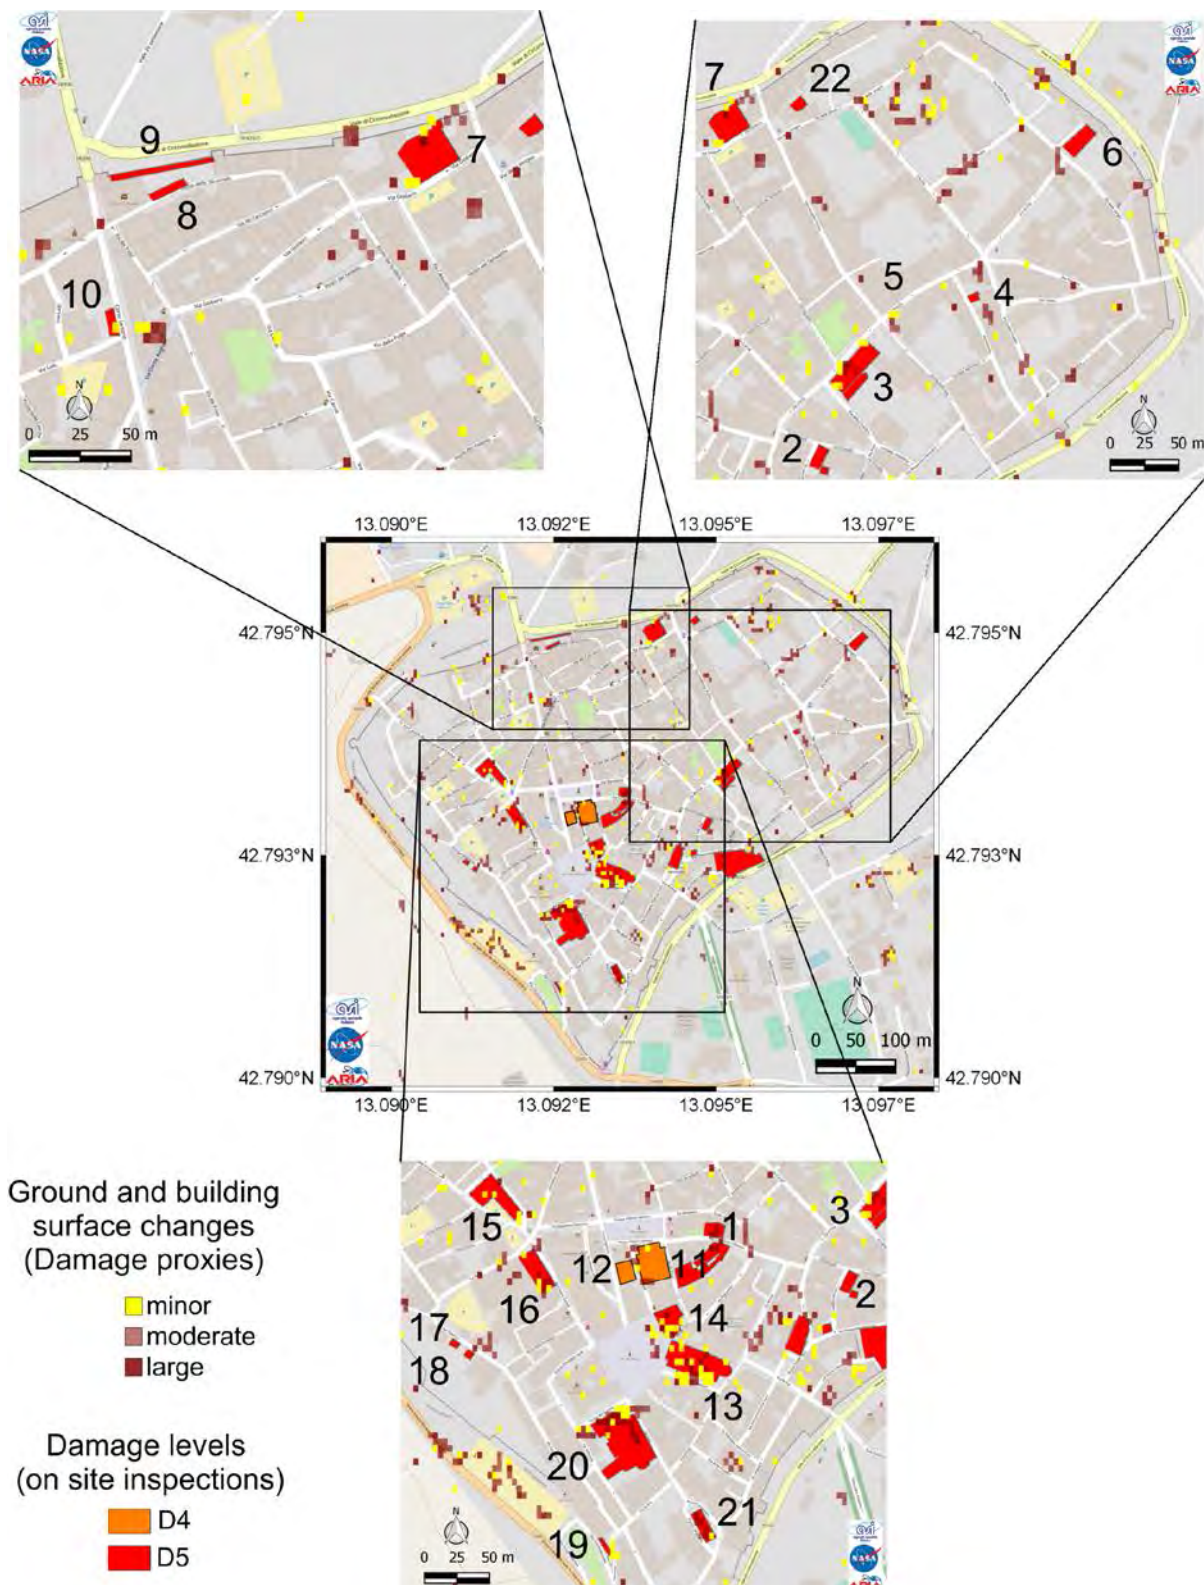
Figure 21 shows the DPM produced for the historical center of Norcia after the **M**6.5 30 October event, that is, the end of the earthquake sequence, superimposed with 22 structures that were classified visually as completely collapsed (D5), and selected D4 structures.

By comparing the locations of these mapped structures and the damage zones from ARIA imaging, a good agreement was observed. In particular, for all structures with an assigned damage level of collapse (D5), the DPM accurately showed a concentration of red and dark red zones, representing areas in which substantial deformations occurred.

**Figure 21.** Damage proxy map of Norcia, along with the identification numbers of all structures with assigned damage level D5 and selected structures with assigned damage level D4, from field inspections and available high-quality on-site information and photos.
