Landslides triggered by recent earthquakes in Italy

ABSTRACT

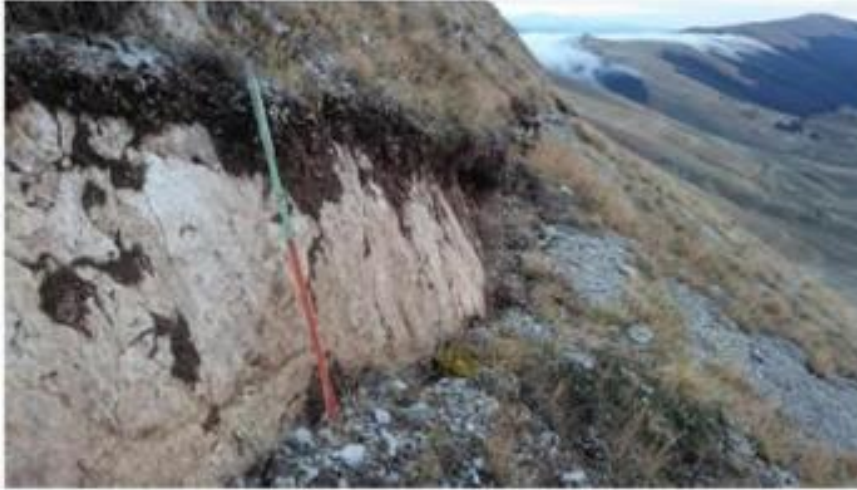
Figure 3: Incremental surface fault rupture on the western slope of Mt. Vettore-Mt. Bove fault.

Figure 3 shows the cumulative fault offset measurement (70 cm) on the lower or “western” fault trace (Lat = 42.812901, Long = 13.24626). A comprehensive overview of fault surface rupture observed during the 2016 Central Italy earthquake sequence is provided by GEER (2017) and Gori et al. (2018).

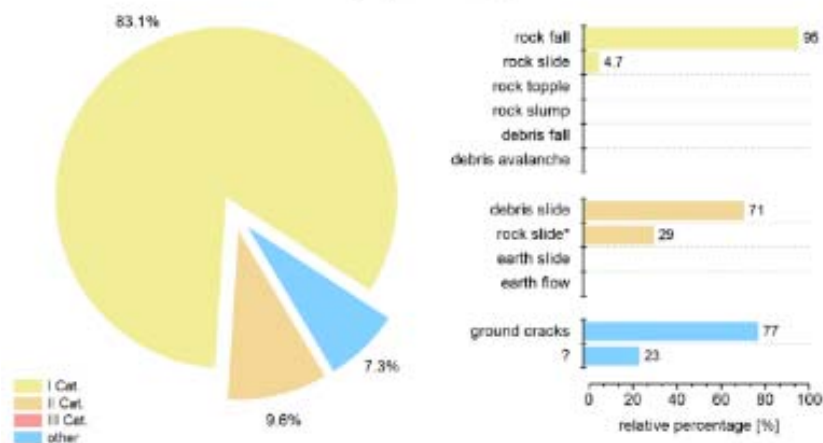
Figure 7: Distribution of recognized landslides after the 24 August event.

Several landslides have been observed following the 24 August mainshock. Figure 6 shows the mapped slope instabilities locations. Table 3 and Figure 7 summarize the percentage of landslides falling into each category and the different types of landslides for each category, following the 24 August event. Most of the observed phenomena fall in Category I and involve mainly small rock falls observed along roadway cuts throughout the earthquake zone.

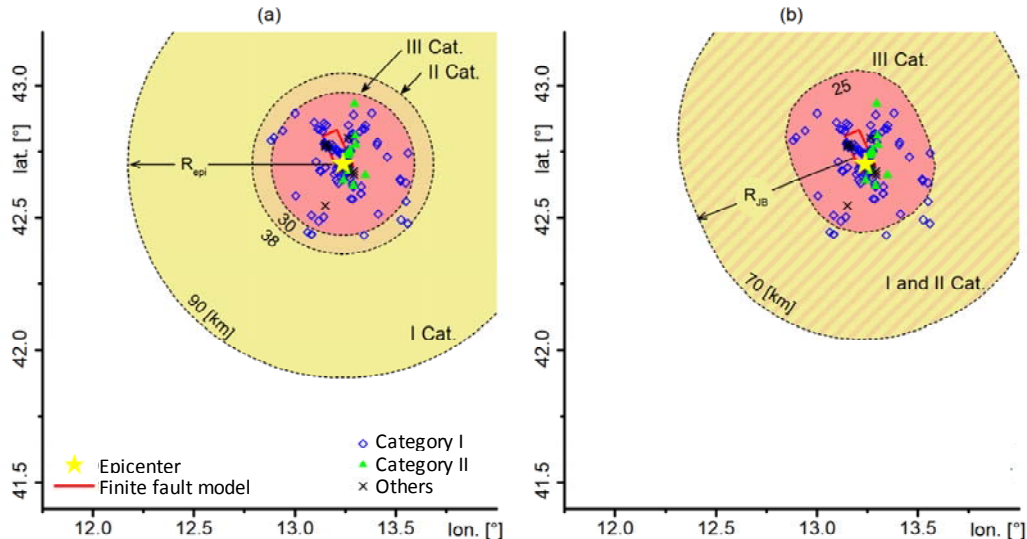
Figure 10: Areal distribution of landslide sites following the 24 August event compared with empirical upper-bound loci defined from Keefer (1985) for two source-to-site distance metrics: (a) epicentral distance, and (b) Joyner and Boore distance.

The comparison with the empirical limits shows that the zone involved in the activation of Category I landslide is limited to an area with a radius of about 40 km around the epicenter (about half the distance limit indicated by Keefer (1985) for this kind of phenomena) with the majority being at 10 km or less from the surface ruptures. Comparing all mapped landslides with the Italian landslide inventory (Inventario dei Fenomeni Franosi in Italia, IFFI project, ISPRA – Dipartimento Difesa del Suolo Servizio Geologico d' Italia, available at: <http://www.progettoiffi.isprambiente.it>), new landslides are mostly in the near-field (<10km), while far-field landslides are present in the pre-existing landslide inventory (Pavlidis et al., 2017).

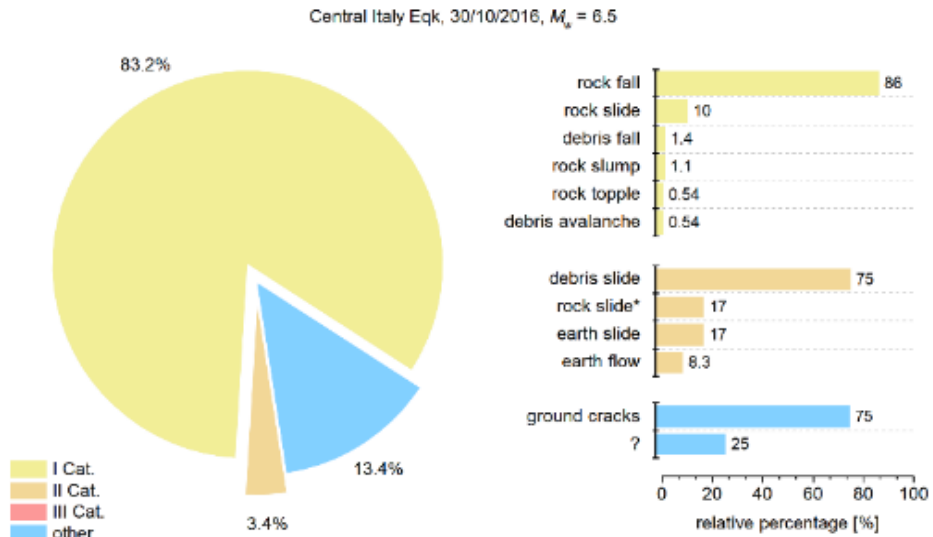
Figure 12: Distribution of recognized landslides after the 30 October 2016 earthquake.

landslides for each category following the October events. Figure 12 shows a graphical representation of the same information for the 30 October event. Similarly to what observed after the 24 August event, most of the observed phenomena fall in category I and involve rock falls.

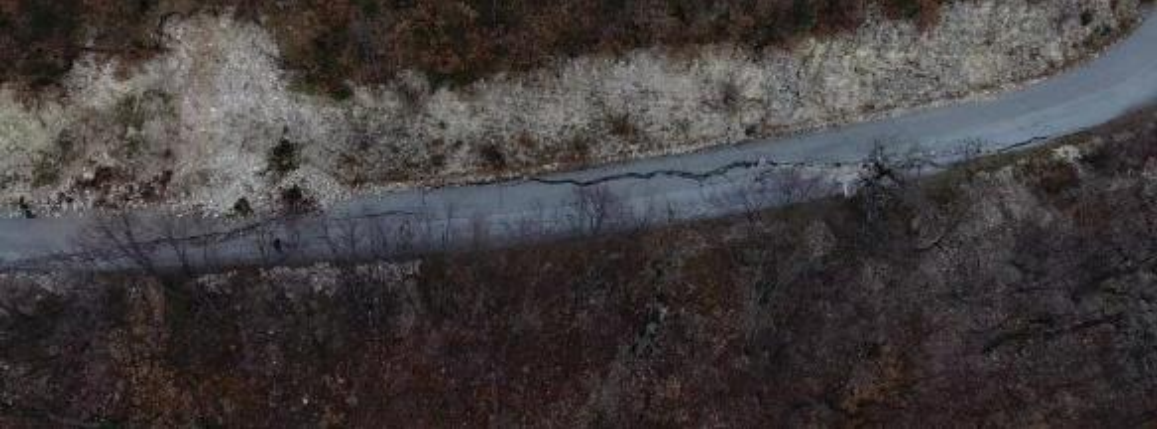
Figure 14: Aerial photograph of the Valle di Panico landslide (from GEER, 2017).

Another interesting rockfall feature is that observed in the Valle di Panico. This instability phenomenon has been likely triggered by the 30 October event. However, this information is only inferred since prior information about it were not available at the time of reconnaissance (Lanzo et al., 2018). Mt. Bove represents the southern flank of the narrow valley called Valle di Panico. The northern flank of this valley is formed by a succession of limestone and marly units from Jurassic to Cretaceous in age. Two landslide locations along the mountain road that winds along the northern flank of Valle di Panico are present. The road is cut into thinly-bedded marly limestones (Scaglia Bianca Formation) whose bedding joints frequently have a clay/bituminous infilling. This structural/lithologic feature together an intense fracturing gives the rock mass quality a low quality. The source area of the rock fall at the second site is located in a marly-limestone unit featured by

thicker layer. In this area the bedrock is extensively covered by slope debris some meter thick (GEER, 2017). The GEER reconnaissance team visited two main sites in the Valle di Panico area. The first site was a landslide in the soil slope through and beneath the road. [Figure 14](#) shows an aerial photograph of this 55-60m wide landslide. The GEER team measured a vertical offset on the road pavement ranging between 10-70 cm, and an horizontal deformation ranging from 2-40 cm. The GEER team also created UAV-based 3D models of this landslides. As shown in [Figure 15a](#), the eastern portion of the landslide headscarp shows distinct cracks and associated displacements. The western portion of the headscarp appears more gradual and shows pavement cracking ([Figure 15b](#)).

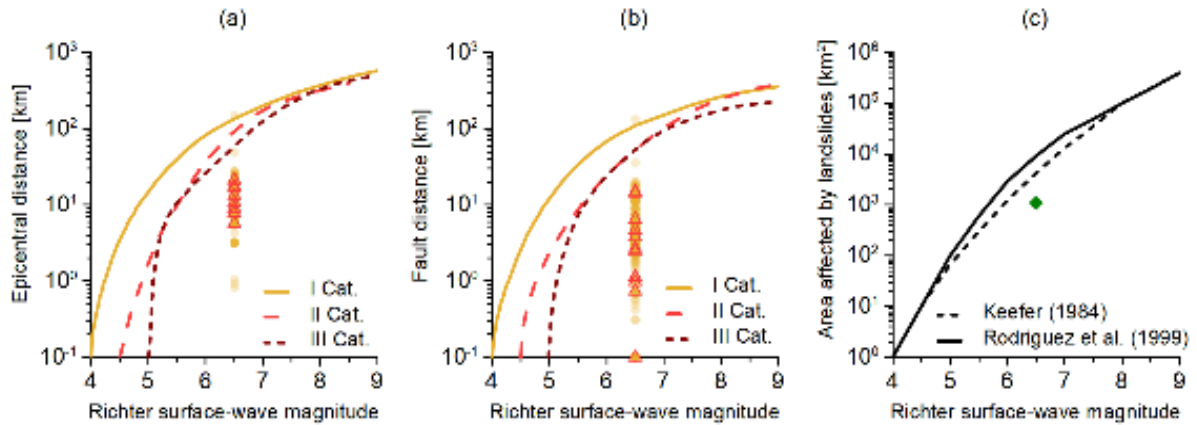
Figure 18: Comparison between source-to-site distances for landslides occurred following the 30 October event and the empirical upper-bound curves proposed by Keefer (1985) in terms of (a) epicentral distance and (b) Joyner and Boore distance; (c) comparison between the envelope area affected by landslides and the upper bound proposed by Keefer (1984) and Rodriguez et al. (1999).

Figure 18 shows landslide data for the 30 October event compared with the empirical upper bound limits defined by Keefer (1985) in terms of Richter surface-wave magnitude vs epicentral distance (Figure 18a) and Joyner and Boore distance (Figure 18b). Figure 18c shows the comparison between the envelope area affected by landslides and the upper bound proposed by Keefer (1984) and Rodriguez et al. (1999). The same information is reported in planar view in Figure 19. It shows the areal distribution of landslide sites compared with empirical upper-bound loci defined from Keefer (1985) for two source-to-site distance metrics: epicentral distance (Figure 19a), Joyner and Boore distance (Figure 19b). The comparison with the empirical limits shows that the zone involved in the activation of Category I landslide is limited to an area with a radius of about 40 km around the epicenter with the majority being at 10 km or less from the surface ruptures.

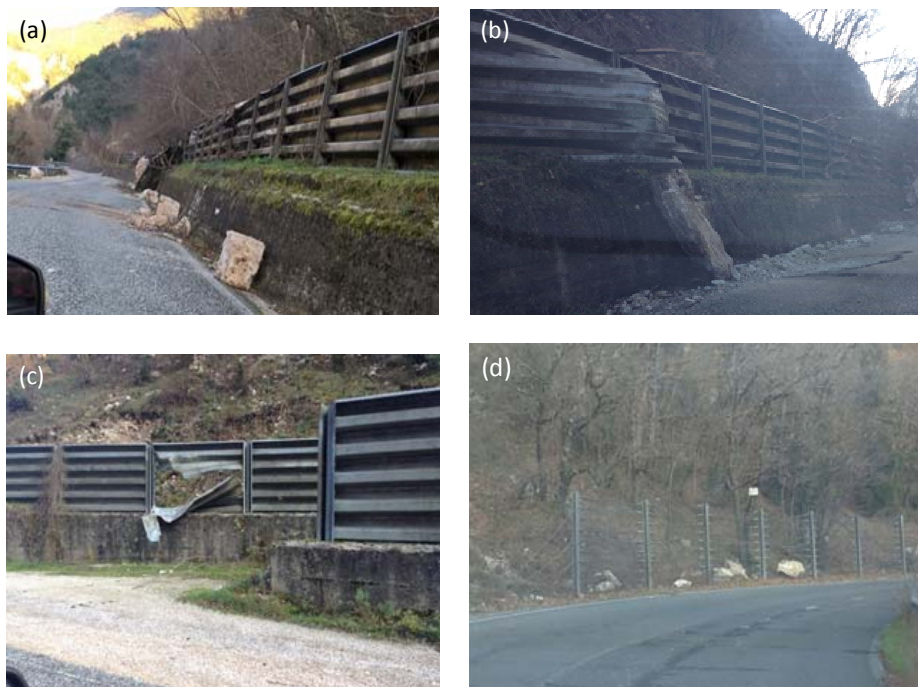
Figure 25: Slope protection damaged by boulders and rock-blocks along the regional road SP 290 in the Nera river valley (adapted from GEER, 2017).

In some stretches the regional road (SP 209) runs along the Nera river. The Italian landslide inventory (Inventario dei movimenti franosi in Italia, IFFI project, ISPRA Dipartimento Difesa del Suolo Servizio Geologico d'Italia) classifies this area as subjected to rock falls and slumps. The Nera river valley area is characterized by sedimentary rocks of the carbonate Umbria-Marche stratigraphic sequence, an early Jurassic to Eocene age formation. The geology of the area (Romeo et al. 2017) is characterized by the outcropping of the Umbria Marche sequence from the Calcare Massiccio (a massive platform limestone) to Scaglia Variegata-Cinerea (marly-calcareous rocks). The Maiolica Formation (stratified pelagic limestone) is present in the left bank of Nera river. In some parts, the formations are pervasively folded (crumpled) and intensely fractured (Romeo et al., 2017). Several rockfalls and diffuse instabilities occurred along this valley during the 2016 Central Italy earthquake sequence. Very few and small landslides were triggered by the 24 August event, while sever rock falls occurred following the October 2016 events. Boulders with a volume ranging from a dozen of cubic centimeters to a few of cubic meters, have been observed on the shoulders and/or across the road. [Figure 25](#) shows cases in which the installed rockfall protection measures are passed over, severely damaged or destroyed. These passive protection measures (i.e. rockfall nets, dynamic rockfall barriers, rigid barriers or catch fences) were built along the SP 209 stretch after the 1997 Umbria Marche earthquake sequence which triggered about 200 rockfalls of various sizes along the Nera River Valley, and damaged man-made infrastructures such as roads, bridges and tunnels (Carro et al. 2003; Gigli et al. 2014).

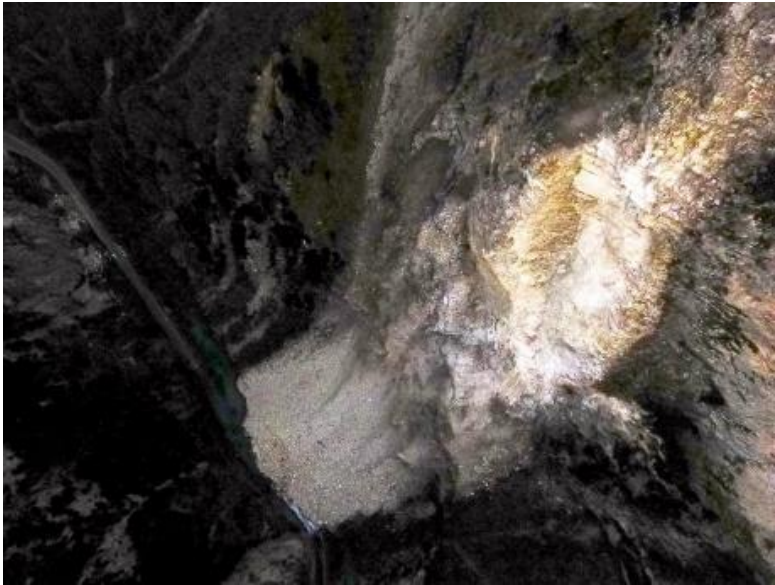
Figure 26: Nera rockslide photographed by the GEER UAV at an elevation of 400 meters above Route SP 209. The primary rock-fall was a wedge that detached on the right side of the image and disintegrated into talus debris as it fell 330 meters to the river valley floor. The limestone bedding is visible in the scar of the wedge detachment (from GEER, 2017).

The largest and most important rockfall occurred following the 30 October earthquake, 1 km southwest of Visso, along the steep-faced north slope of Mount Sasso Pizzuto, which is characterized by highly deformed, stratified, and fractured rocks (Maiolica Formation). The avalanche generated by this rockfall interrupted the regional road (SP 209), dammed the Nera River forming a small lake of about 2000 m². This feature is known as the Nera rockslide or Mount Sasso Pizzuto rock fall. This rock avalanche impacted the road transportation between Visso and the town of Terni (seat of administrative and industrial activities in the Umbria region) and the transportation network within the whole Central Apennine chain. The avalanche deposit has also damaged fish farming activities (a significant financial income for the area). The presence of such fish farming activities, along with obvious environmental concerns imposed extra care in the removal of the landslide dam, making this operation last a long time. Detailed geometric information can be found in report GEER (2017) and in Romeo et al. 2017. In both papers, for geometric characterization, for safety reasons, measurement

Quantitative measurements of the geometry of the rockslide scar and the avalanche deposit were made from photogrammetric reconstruction of images captured by UAV during flights conducted at the beginning of December, 2016 by the GEER team (GEER, 2017). A 3D reconstruction was performed using the Structure-from-Motion (SfM) computer vision post-processing and geo-referencing of the acquired UAV data (more details in GEER, 2017). The resulting 3D model is shown in Figure 26. Figure 27 shows details of the talus damming the Nera river (Franke et al., 2018). Romeo et al. (2017) have used a TruPulse™ 200 laser rangefinder. The laser sensor was placed on a tripod allowing the measure of slope distance, horizontal and vertical distance, inclination, or to calculate the elevation of any target. Thirty points were targeted on the landslide debris that covers an area of about 16,500 m². Furthermore, GIS analysis was defined in ArcGIS 10.1 (more details in Romeo et al. 2017).

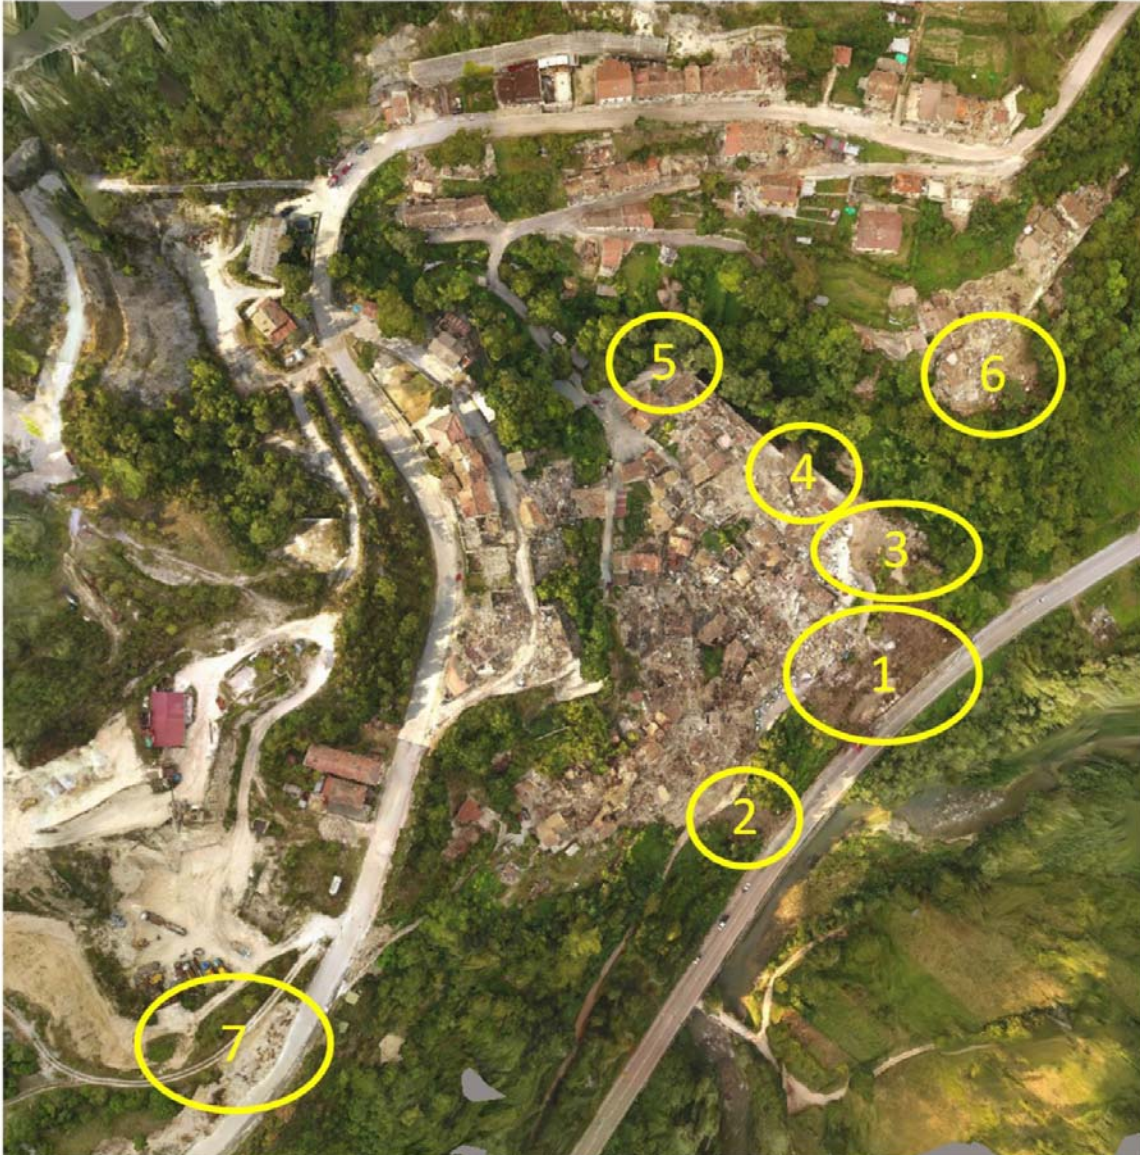
Figure 28: 3D model of Pescara del Tronto following the 24 August event. Yellow circles highlight the seven locations of interest discussed in this report.

After the August events, investigation of the 3D models of Pescara del Tronto produced by the GEER team (GEER, 2016 and 2017) revealed numerous shallow earthquake-induced landslides and retaining wall failures. The remainder of this section summarizes incremental slope instability features observed as a result of the 2016 Central Italy earthquake sequence. This analysis is largely based on multi-epoch observations mainly derived from UAV-based 3D models. A total of seven locations of interest within Pescara del Tronto have been identified to perform the cumulative damage analysis (Figure 28; GEER, 2016 and 2017).

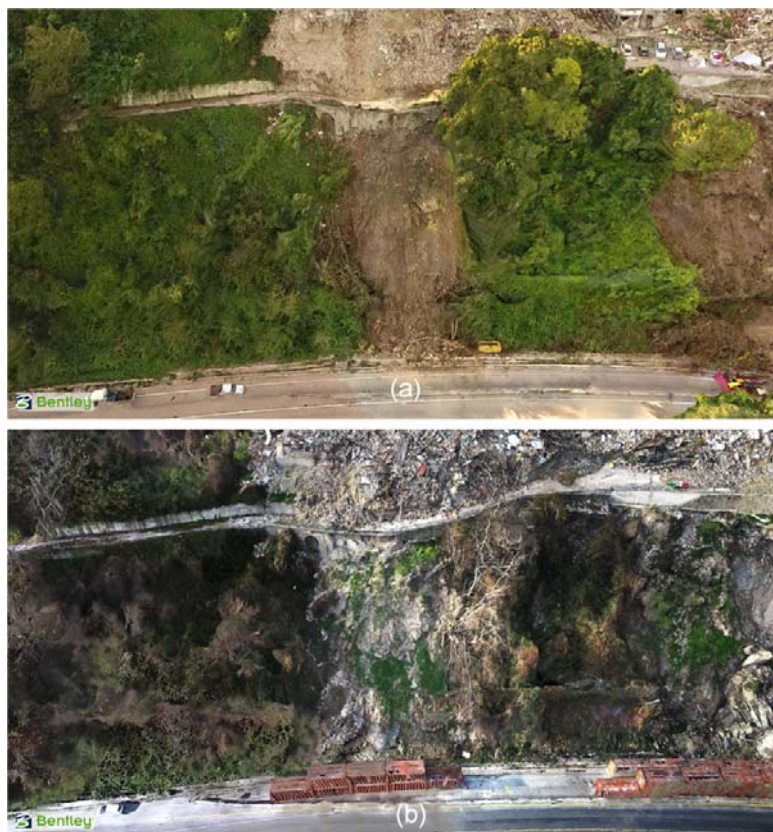
A second, smaller shallow landslide was located above Highway SS4 (marked as #2 in Figure 28), just south of the larger landslide #1 (42.7501 N 13.2719 E). This landslide was approximately 16m wide and occurred on a slope 26m high. [Figure 30](#) shows a comparison between 3D models produced for this feature following the 24 August and 30 October events. This smaller landslide was not observed to change significantly after the 24 August event ([Figure 30a](#)) and the 30 October earthquake ([Figure 30b](#)). In this section, the retaining wall supporting the road appeared to maintain its stability. However, significantly more structural debris from collapsed residences was observed at this location in following the 30 October earthquake.

Figure 30: 3D model of the landslide #2 in Pescara del Tronto following: (a) the 24 August and (b) the 30 October event (from GEER, 2017).

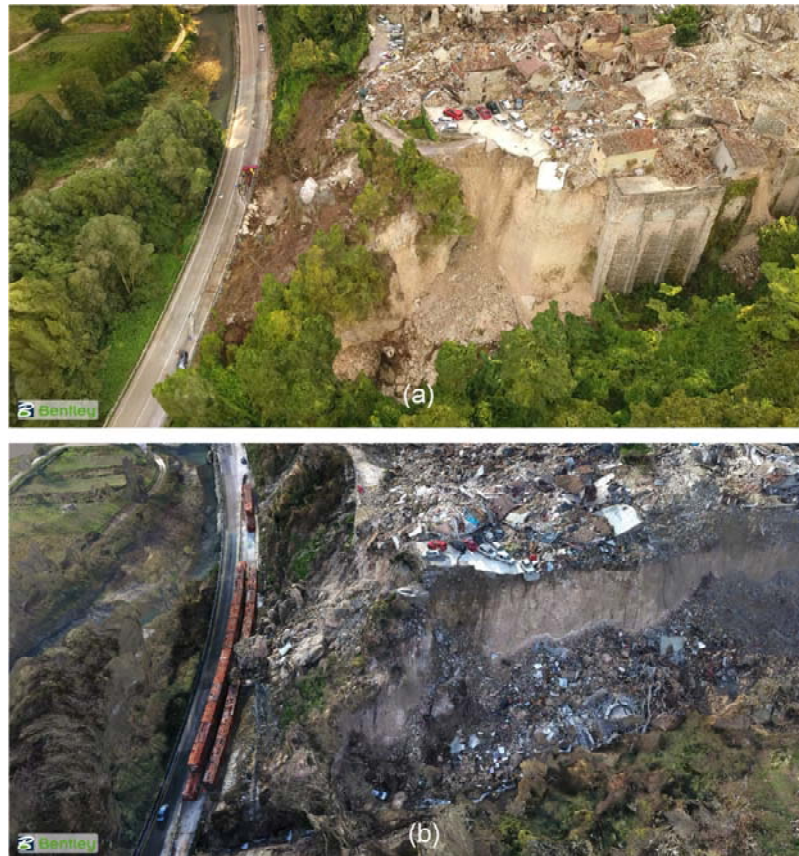
A few of the observed slope failures in Pescara del Tronto appear to be related to potential retaining wall failures. The lower portion of Pescara del Tronto was partially supported by a 24 m-tall masonry retaining wall that surrounded the foot of the village. This wall suffered serious damage following the 24 August event (Figure 31a). Substantial damage accumulation has been observed following the October events as shown in Figure 31b. In Pescara del Tronto, structure debris was so ubiquitous that it was challenging to investigate ground deformations in this zone. Any attempt to directly investigate this zone was infeasible due to the dangerous and unstable nature of the debris field. As a result, UAV-based imagery constituted the main damage detection and analysis tool, especially after the October events. Moderate to severe damage was observed in most of the roads located adjacent to slopes and/or above retaining walls throughout Pescara del Tronto.

Figure 31: 3D model of the failed retaining wall area in Pescara del Tronto (areas #3-4 in Figure 28) following: (a) the 24 August and (b) the 30 October event (from GEER, 2017).

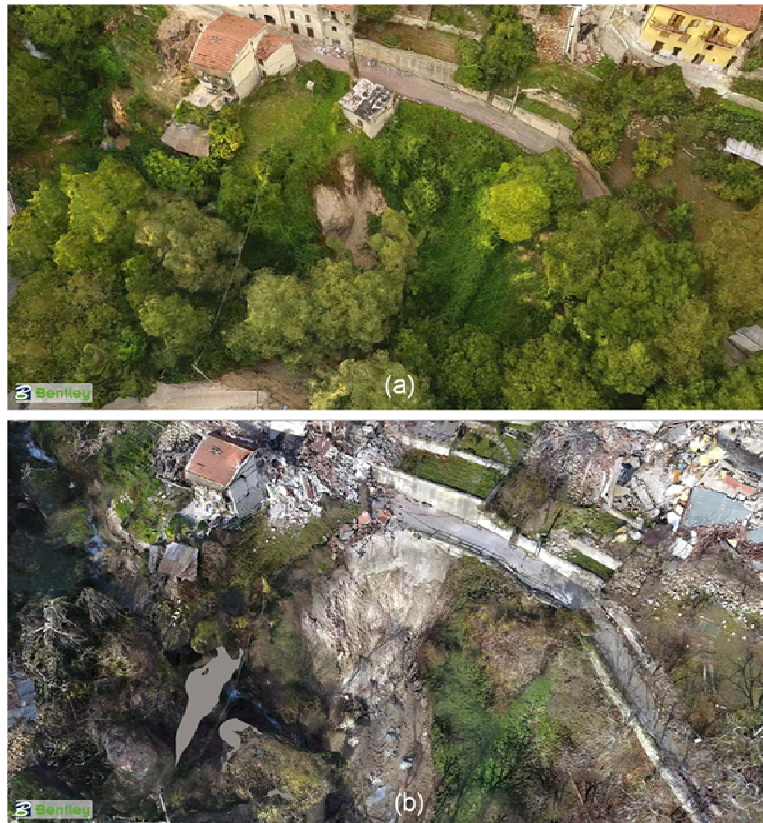
Figure 32a shows a minor sloughing of the gully wall observed following after the 24 August event from UAV-based imagery (feature #5 in Figure 28). In the same area, UAV-based imagery captured following the October earthquake events shown that a section of the slope nearly 9m thick and 20m wide failed into the gully (Figure 32b). The remaining scarp is nearly 12 m in height and stands with at an angle of 52 degrees, remarkably similar to the same scarp angle that remains behind the failed lower retaining wall (i.e., Areas 3 and 4). A small residential structure that was observed to rest on top of the slope after August event had plummeted into the gully after the October event.

Figure 32: 3D model of the failure observed in area #5 in Figure 28 following: (a) the 24 August and (b) the 30 October event (from GEER, 2017).

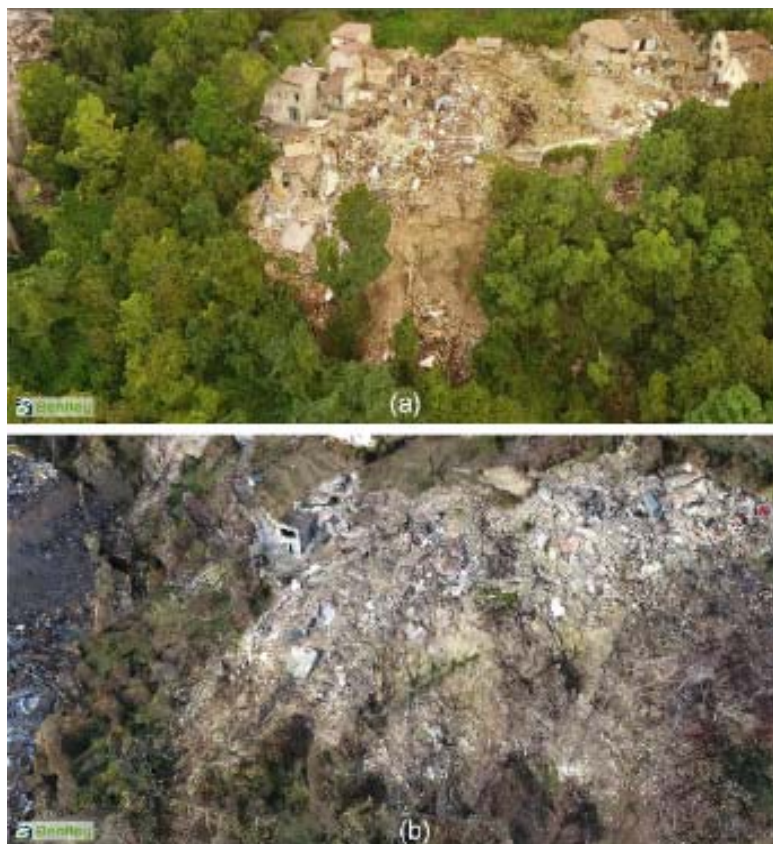
Another shallow landslide occurred on the northern side of Pescara del Tronto (marked as #6 in Figure 28) following the 24 August event (Figure 33a). This landslide is approximately 17m wide by 20m high. A significant amount of structural rubble from collapsed residences is also visible in the landslide debris. Additional observations performed following the October events revealed that the depth of the landslide remained relatively unchanged, but its width expanded from 17m to more than 36m (Figure 33b). In both cases (following the 24 August and the October events) landslide size measurements have been performed using UAV-based imagery (GEER, 2017).

Figure 33: 3D model of landslide #6 following: (a) the 24 August and (b) the 30 October event (from GEER, 2017).

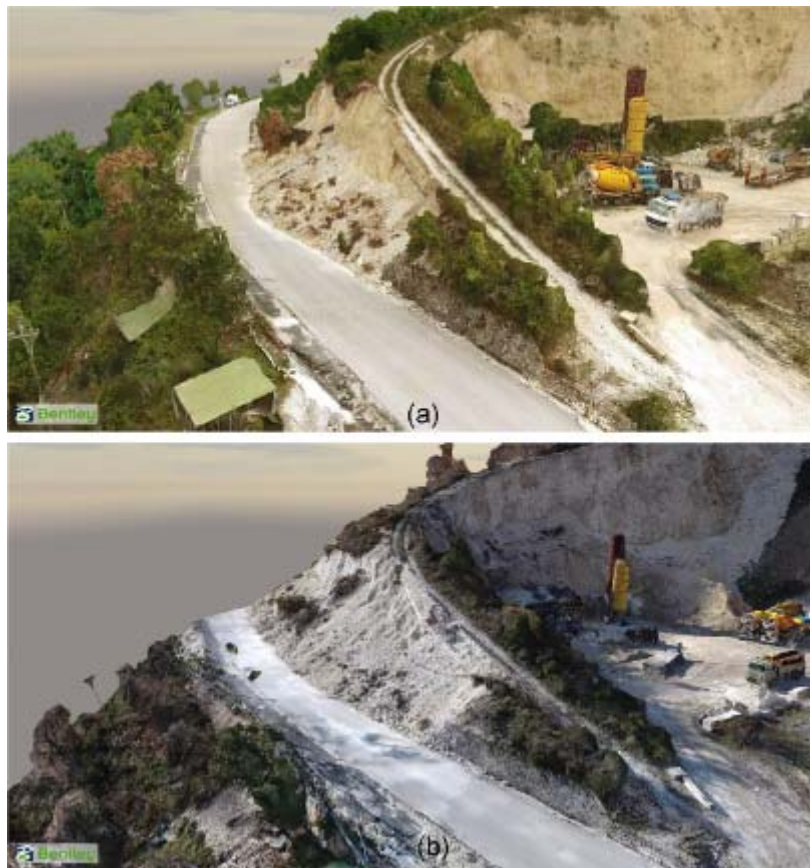
The last landslide feature present in this report in the area of Pescara del Tronto is located on the slope bounding the gravel pit on the southern upper portion of the village adjacent to the SP 129 highway (marked as #7 in Figure 28). Observations made following the 24 August event show that the gravel pit is approximately 70m by 90m, and has 2.4V:1H side slopes comprised of slightly cemented cartaclasized limestone blocks interspersed in a gravelly-sandy matrix comprised of angular limestone clasts (Figure 34a). A dirt haul road traveling up and along the edge of the slope is located on the south side of the gravel pit. The landslide exposed about 15m of a 50 cm-diameter pipeline that was shallowly buried beneath the dirt haul road. The shape and size of the landslide remained almost unchanged following the October earthquake events as shown in Figure 34b. However, the slope beneath the haul road degraded slightly more, causing nearly half of the haul road above the landslide to disappear. Approximately 8 more meters of the pipeline became exposed from the additional slope movements, causing the pipeline to apparently sag and bow slightly. Another smaller pipe of a few centimeters' diameter was also exposed and sagging substantially along the scarp.

Figure 34: 3D model of landslide #7 and exposed pipeline following: (a) the 24 August and (b) the 30 October event (from GEER, 2017).

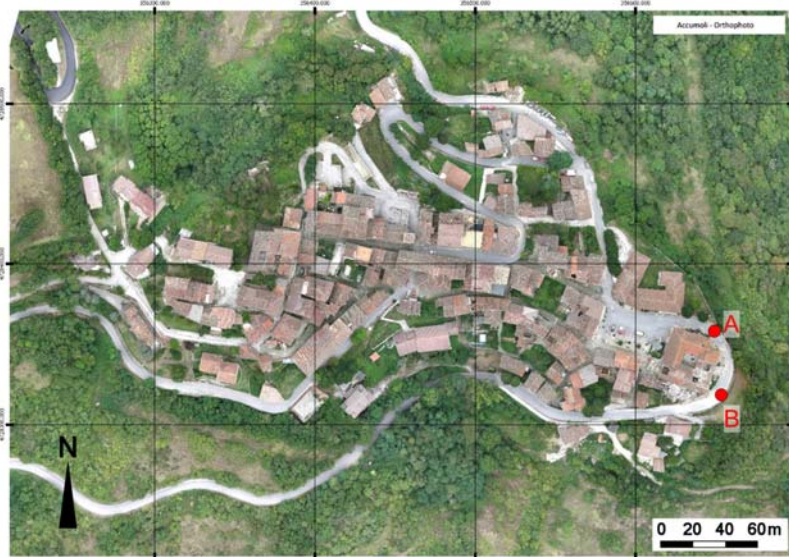
Figure 35: Accumoli map with location of the landslide-related damages observed during the August and October events (from Lanzo et al., 2018).

Accumoli is a small village in the Rieti province, located on top of an elongated WNW-ESE ridge at an elevation spanning from 860 to 890 m a.s.l. (Figure 35). The geological bedrock in the area is the Laga Formation that therein is mainly arenaceous. This formation, which is often loosened and weathered in its shallower portions, is locally overlaid by colluvial and landslide covers. The village is located in the epicentral area of the 24 August 2016 mainshock. Accumoli suffered damages during the 14 January 1703 Valnerina earthquake (M6.9). Zimmaro et al. (2018) estimated $PGA=0.40g$ during the 30 October event and $PGA=0.55g$ during the 24 August event in Accumoli (Table 2). Structural and landslide-related damage observed following the October events (GEER, 2017) was significantly larger than that observed following the August event and documented in GEER (2016).

We analyze landslide-related damage occurred in two zones: (1) Point A in Figure 35: incremental damage to a retaining wall, and (2) Point B in Figure 35, shallow slope failure on eastern side of the village. Following the 24 August event, a 4.8 m-tall retaining wall located at the eastern tip of the spur was observed to have rotated outwards 3.6 degrees, with horizontal movements of 57 cm and downward vertical movements of nearly 18 cm. A soil graben nearly 2.7 m wide was observed behind the rotated wall, with soil settlements of 45-50 cm. Much more damage was observed following the October events. It appeared that a shallow landslide developed beneath the retaining wall and caused the entire structure to slide several meters down the slope.

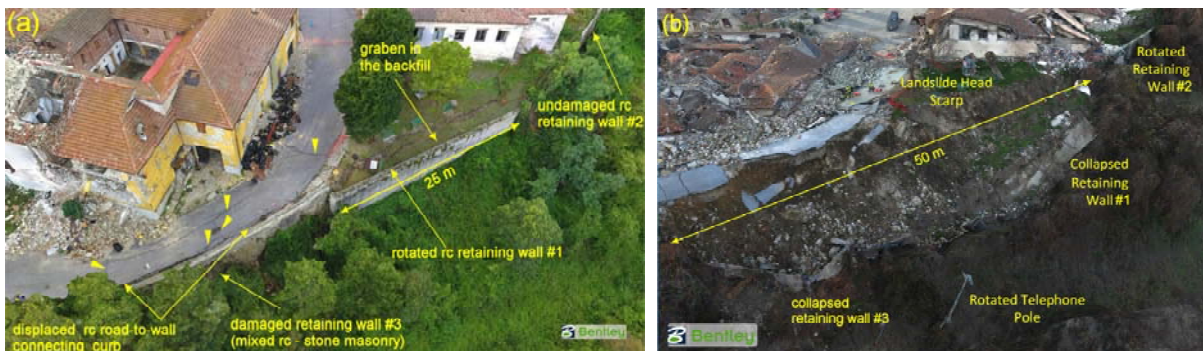
Figure 36 presents an aerial screenshot of the 3D model developed from UAV imagery of the site, showing evident incremental damage as a result of the earthquake sequence. The shallow landslide appeared to be limited to the upper corner of the slope, near the crown. The slide therefore likely occurred in the non-native fill slopes placed during the construction of the village. The scarp of the landslide appeared to follow the scarp of the soil graben observed behind the wall following the 24 August event, suggesting that the graben may have been caused by more than just the rotation of the retaining wall. The landslide displaced the top of the wall between 5 to 6 m horizontally and between 3 to 4 m vertically downward. In total, approximately 50 m of the retaining wall failed and slid 5 to 6 m downslope. Further south to Point A, a series of shallow cracks (orthogonal to the dip of the slope) approximately 5-14 cm in width were observed following the 24 August event. These cracks extended after the October events up to a width ranging between 80-190 cm. The depth of the cracks was approximately 55 cm.

Figure 36: 3D model screenshots following: (a) the 24 August, and (b) 30 October event (from Lanzo et al., 2018).
